MUD PUMP GEARING FAILURE ANALYSIS

PROJECT DESCRIPTION

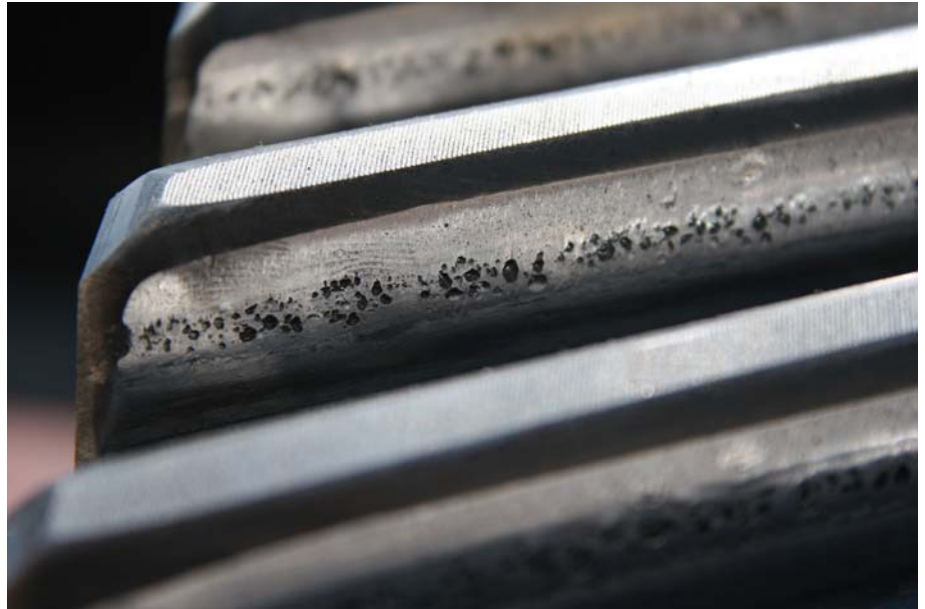
IT WAS DETERMINED THAT THE GEARING WAS PITTING IN A RELATIVELY SHORT AMOUNT OF TIME AND THAT A NUMBER OF FACTORS AFFECTED THE PITTING CAPACITY:

- AN EXCESSIVE AMOUNT OF THE TOOTH PROFILE WAS BEING REMOVED DURING DE-BURRING.
- THE HEAT TREATMENT WAS FOUND TO BE INCONSISTENT AND INSUFFICIENT.
- THE GEAR WAS DESIGNED AS A STUB-TOOTH DESIGN, FURTHER REDUCING THE PITTING CAPACITY.

- REDESIGN OF THE GEAR GEOMETRY TO IMPROVE THE PITTING CAPACITY.
- IMPLEMENTING A PLAN TO VERIFY MANUFACTURED GEAR AND PINION TOOTH QUALITY, HEAT TREAT QUALITY, HOUSING ACCURACY, AND ASSEMBLY ACCURACY.
