MUD PUMP GEARING FAILURE ANALYSIS

PROJECT DESCRIPTION

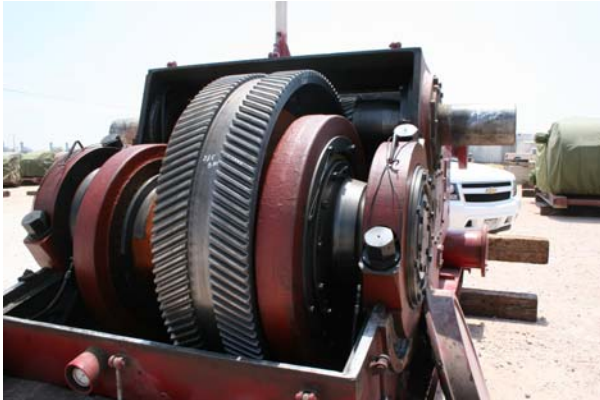
A CLIENT WAS HAVING ISSUES WITH PREMATURE FAILURES ON THE GEAR AND PINION OF A 1,000 HP MUD PUMP. I WAS ASKED TO INSPECT TWO RETURNED UNITS, DETERMINE THE FAILURE MECHANISM, IDENTIFY ANY DESIGN DEFICIENCIES, AND RECOMMEND CHANGES TO THE DESIGN AND/OR PROCESS TO REDUCE THE LIKELIHOOD OF FUTURE FAILURES.

IT WAS DETERMINED THAT THE GEARING WAS PITTING IN A RELATIVELY SHORT AMOUNT OF TIME AND THAT A NUMBER OF FACTORS AFFECTED THE PITTING CAPACITY:

- AN EXCESSIVE AMOUNT OF THE TOOTH PROFILE WAS BEING REMOVED DURING DE-BURRING.
- THE HEAT TREATMENT WAS FOUND TO BE INCONSISTENT AND INSUFFICIENT.
- THE GEAR WAS DESIGNED AS A STUB-TOOTH DESIGN, FURTHER REDUCING THE PITTING CAPACITY.

- REDESIGN OF THE GEAR GEOMETRY TO IMPROVE THE PITTING CAPACITY.
- IMPLEMENTING A PLAN TO VERIFY MANUFACTURED GEAR AND PINION TOOTH QUALITY, HEAT TREAT QUALITY, HOUSING ACCURACY, AND ASSEMBLY ACCURACY.
